TS-AMD-83056e
November 1984

AERIAL PHOTOGRAPHIC ANALYSIS OF WASTE STUDY SITES

Montana

AERIAL PHOTOGRAPHIC ANALYSIS
WASTE STUDY SITES

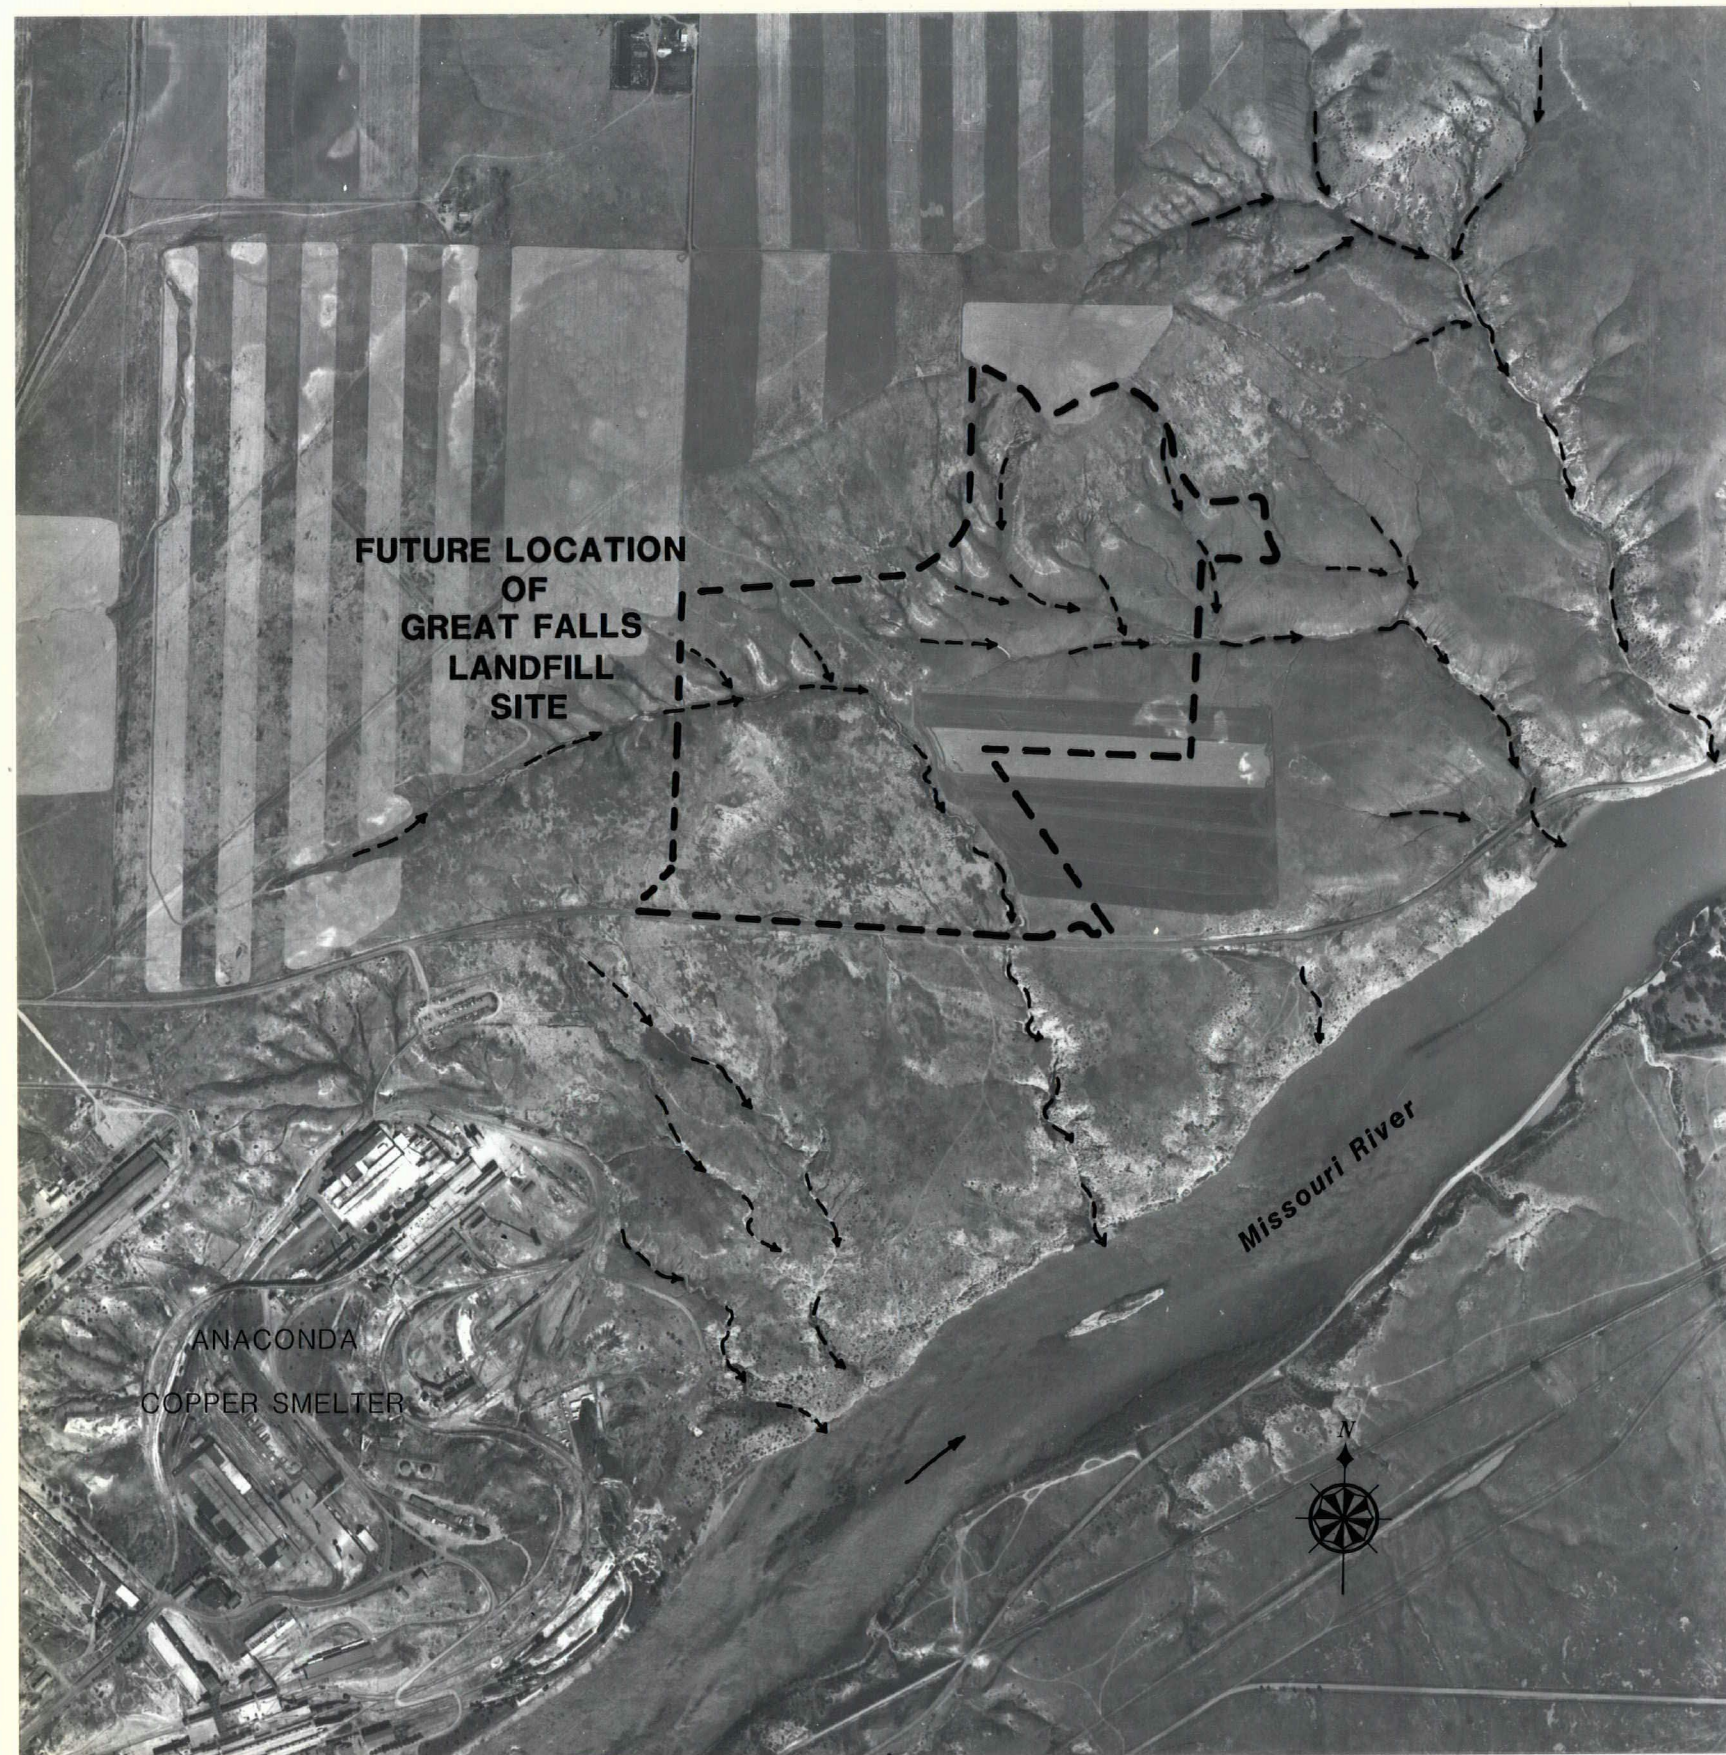
Figure 16. Great Falls Landfill site, August 27, 1950. Approximate scale 1:10,500.

Figure 16 shows the location of the Great Falls Landfill site prior to any waste disposal activity. The outline depicted shows the site at its greatest areal extent which occurred in 1966 (Figure 18). The area is occupied by undeveloped steppe lands. Agricultural lands are located immediately north of the future site location. A significant drainage runs through the northern section of the site area. This drainage eventually reaches the Missouri River 0.6 kilometers (0.4 miles) south.

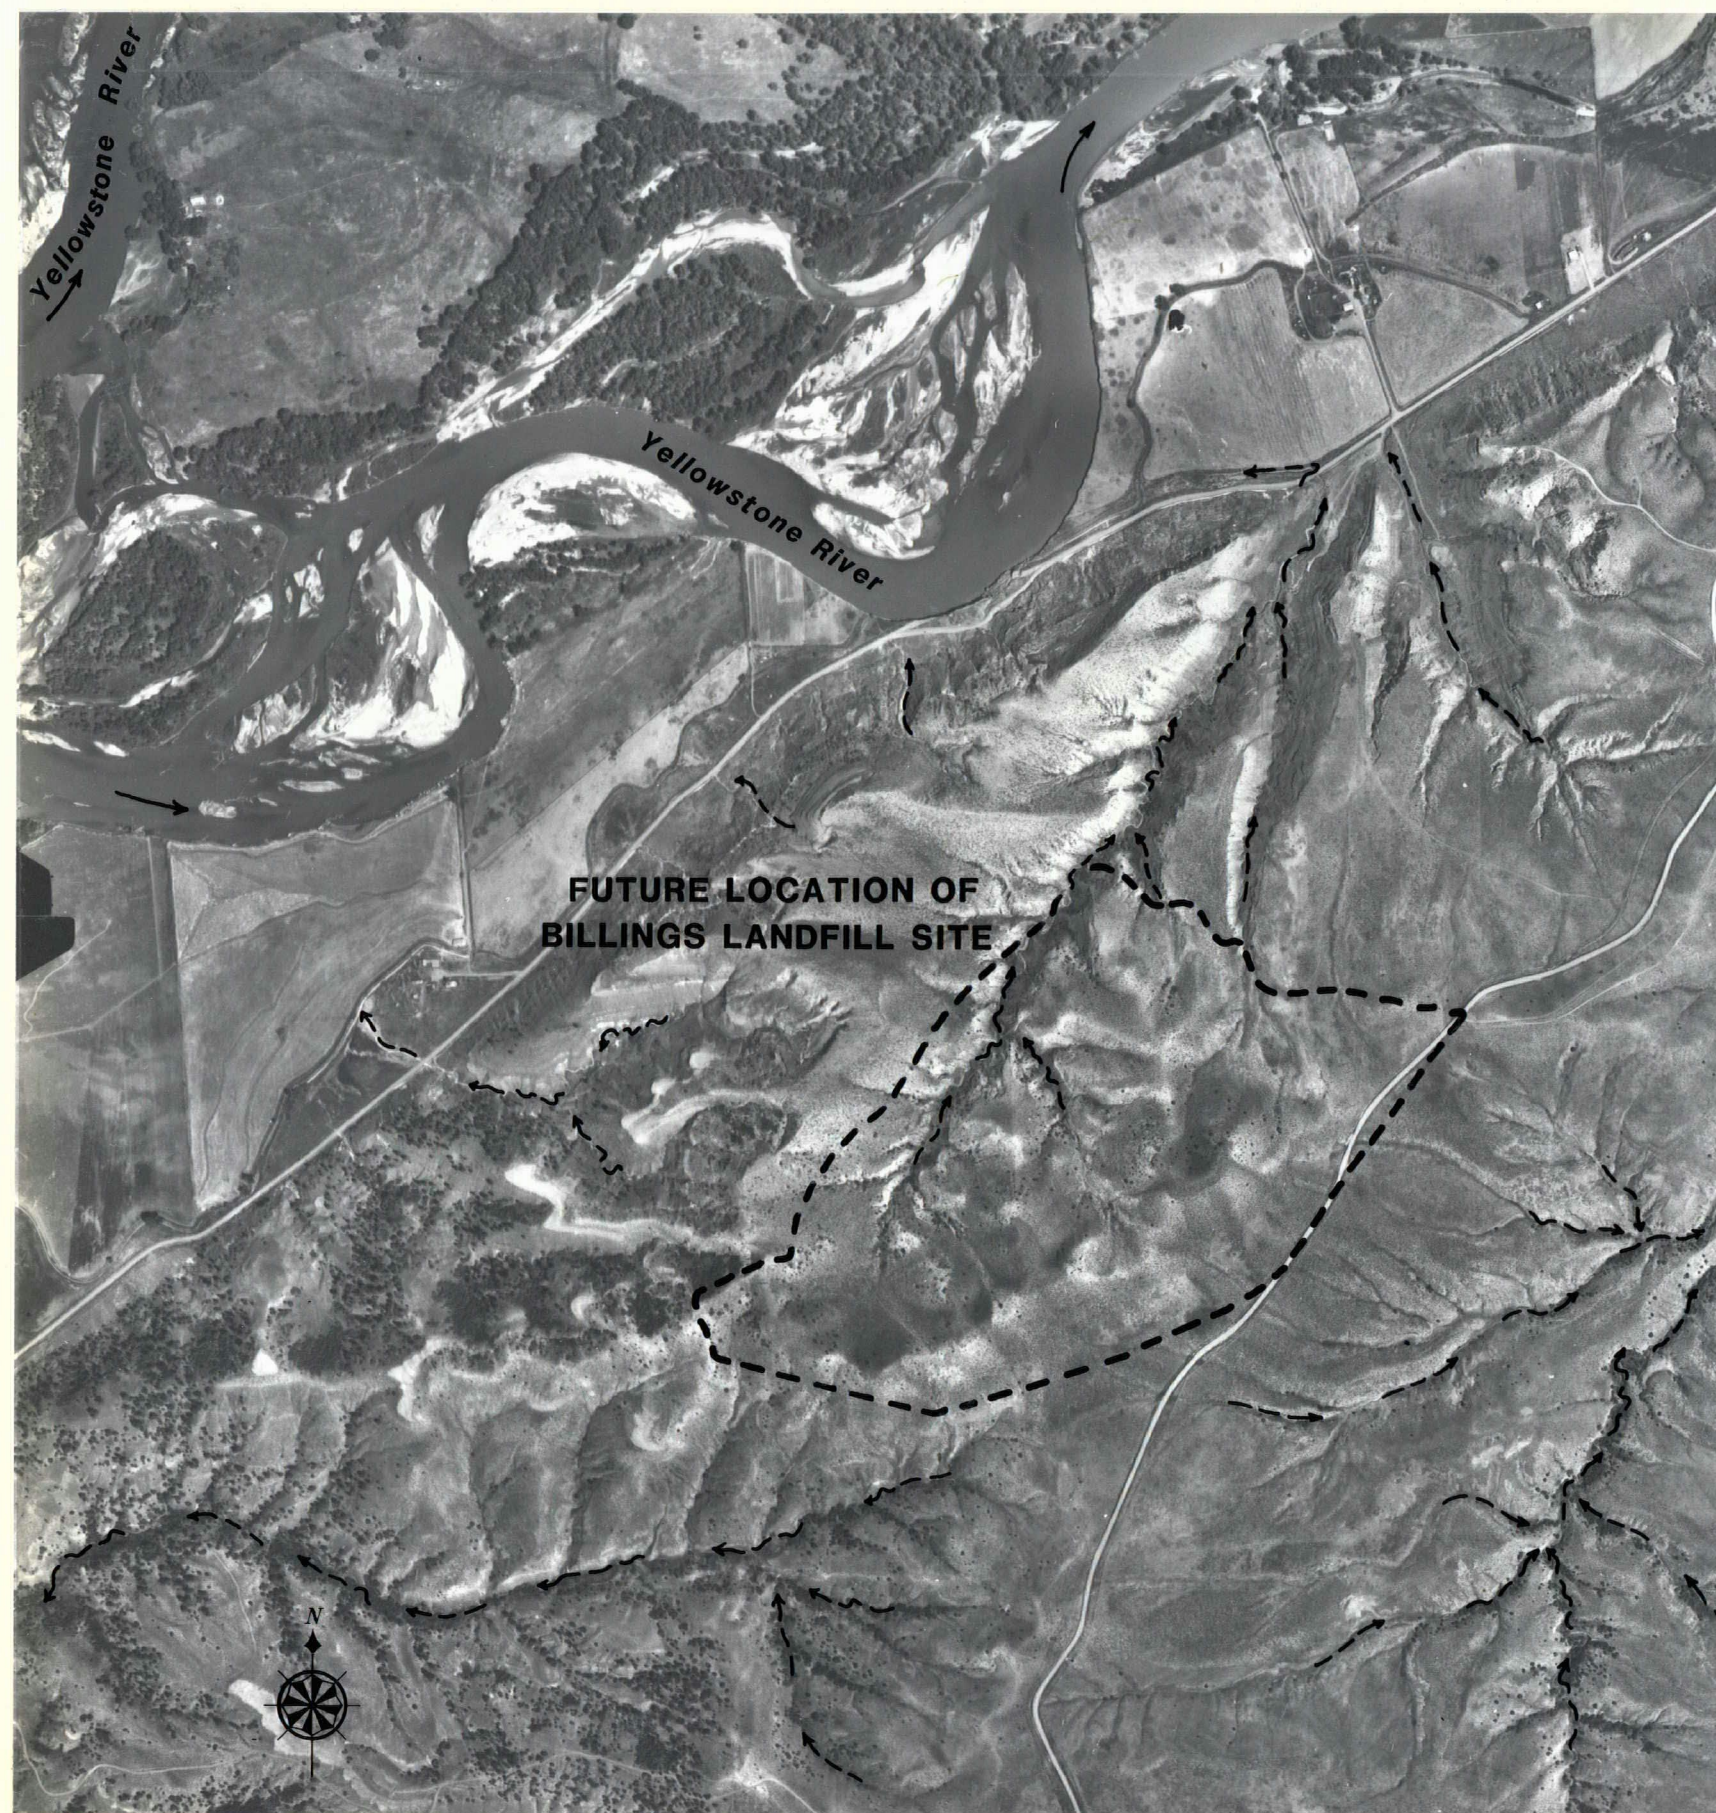
Figure 22. Billings Landfill site, July 16, 1957. Approximate scale 1:12,000.

Figure 22 shows the area later to be occupied by the Billings landfill. The area lies on semi-arid tableland south of the Yellowstone River. The area is dissected by deep ravines and gullys. A small canyon runs northeast through the site area. Drainage is generally to the northeast except for the southern edge of the site where runoff would enter either one of two other small canyons.
